MISCELLANEOUS PAPER NO. 6-761

# SONISCOPE INVESTIGATION OF ELMENDORF AFB HOSPITAL ANCHORAGE, ALASKA

H. T. Thornton, Jr.

December 1965

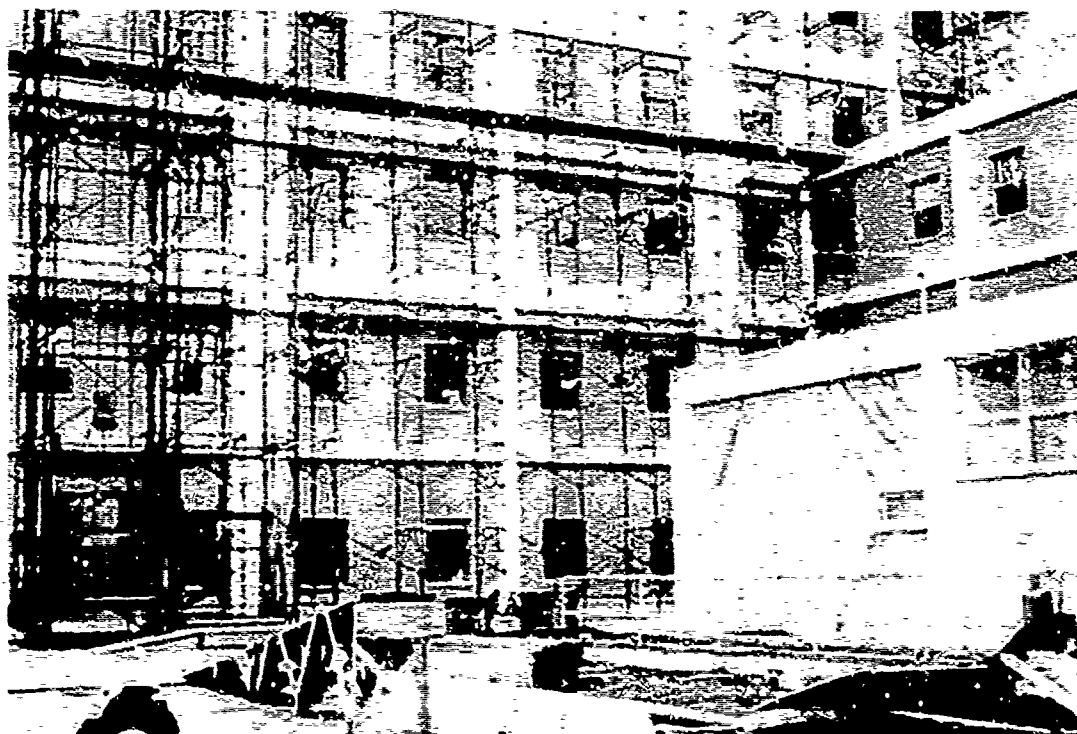
Fig. 5. Third-floor spandrel beam (first wide beam)  
and columns 8 (wide), 10, and 12 (wide)

14. Readings were taken through the outer 6 in. of column-beam connections at columns 8, 10, and 12 (fig. 5) to determine the extent of penetration in the outer face. The locations of these stations and the results of tests are recorded in tables 18, 19, and 20.

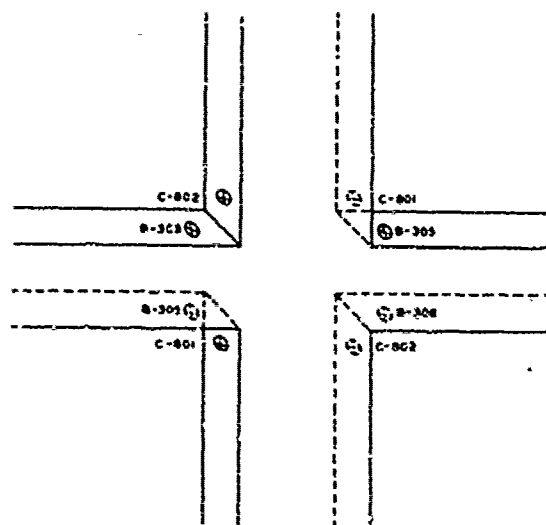
Station location diagram

Results of Soniscope Tests  
 3d Floor Spandrel Beam at Column 8  
 Column-Beam Readings Through Outer 6 in.  
 North Side of Building

<u>Station Numbers</u>	<u>Path Length</u>	<u>Diagonal</u>
	<u>ft</u>	<u>Velocities</u> <u>fps</u>
B-305	5.6	13,965
B-306	5.5	12,305
C-801	5.3	13,695
C-802	5.5	14,250

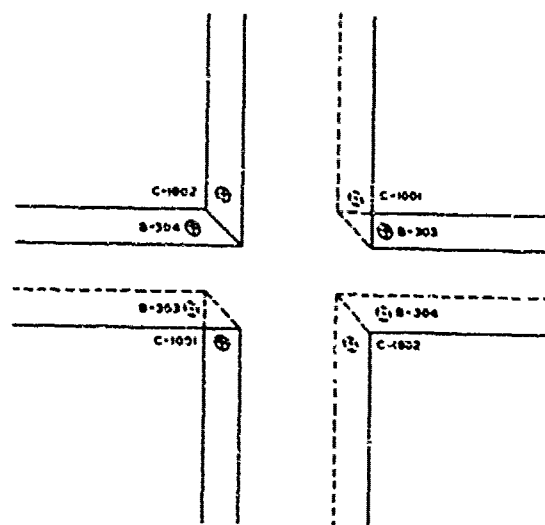
Station location diagram

<u>Station Numbers</u>	<u>Path Length</u> <u>ft</u>	<u>Diagonal</u> <u>Velocities</u> <u>fps</u>
B-303	3.4	12,830
B-304	3.3	12,690
C-1001	3.6	14,575
C-1002	3.7	14,285

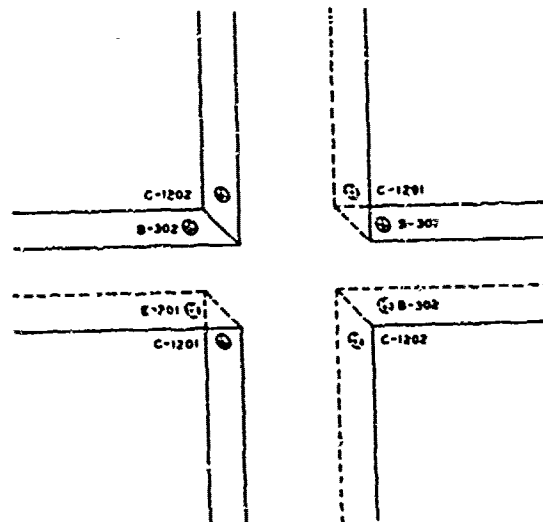
Station location diagram

3d Floor Spandrel Beam at Column 12  
Column-Beam Readings Through Outer 6 in.  
North Side of Building

Station Numbers	Path Length	Diagonal
	ft	Velocities fps
E-301	5.6	13,240
B-302	5.5	9,665
C-1201	5.3	13,250
C-1202	5.4	14,440

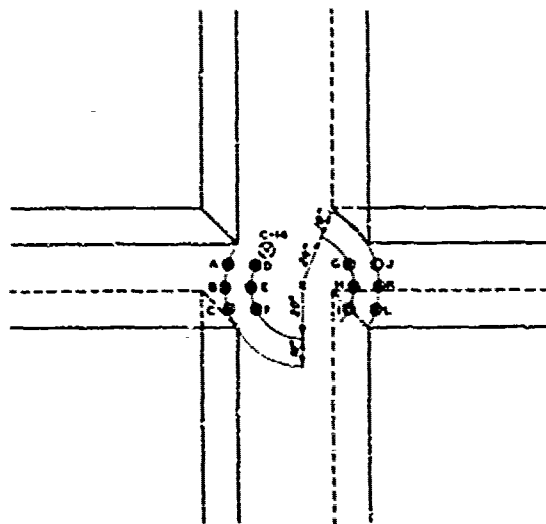
Station location diagram

Readings Through Beams, Columns, and Column-Beam Connections  
(South Side)  
(Not Grouted)

<u>Station Numbers</u>	<u>Path Length ft</u>	<u>Velocities fps</u>	
		<u>Straight Through</u>	<u>Diagonals</u>
C-14	1.17	13,765	
C-14 to A	2.76		7,095
C-14 to B	2.76		10,000
C-14 to C	2.76		11,550
C-14 to D	2.03		11,215
C-14 to E	2.03		11,800
C-14 to F	2.03		11,665
C-14 to G	2.03		13,810
C-14 to H	2.03		13,810
C-14 to I	2.03		13,810
C-14 to J	2.76		13,730
C-14 to K	2.76		13,730
C-14 to L	2.76		13,730

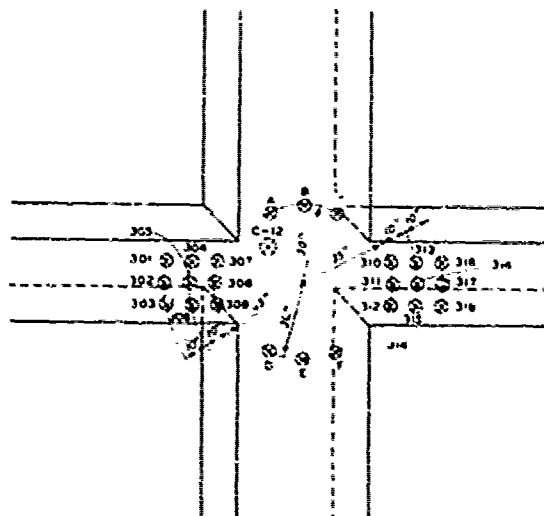
Station location diagram

Station Numbers	Path Length ft	Velocities fps		Station Numbers	Path Length ft	Diagonal Velocities fps
		Straight Through	Diagonals			
C-12	1.17	14,445		C-12 to 306	3.92	10,890
317	1.17	14,625		C-12 to 307	3.14	12,410
C-12 to A	2.76		14,300	C-12 to 308	3.14	12,410
C-12 to B	2.76		14,840	C-12 to 309	3.14	14,080
C-12 to C	2.76		14,605	C-12 to 310	3.14	12,160
C-12 to D	2.76		14,840	C-12 to 311	3.14	10,575
C-12 to E	2.76		14,840	C-12 to 312	3.14	13,420
C-12 to F	2.76		14,840	C-12 to 313	3.92	11,665
C-12 to 301	5.13		12,825	C-12 to 314	3.92	11,430
C-12 to 302	5.13		10,470	C-12 to 315	3.92	11,770
C-12 to 303	5.13		10,620	C-12 to 316	5.13	10,160
C-12 to 304	3.92		8,635	C-12 to 317	5.13	9,585
C-12 to 305	3.92		8,200	C-12 to 318	5.13	10,645

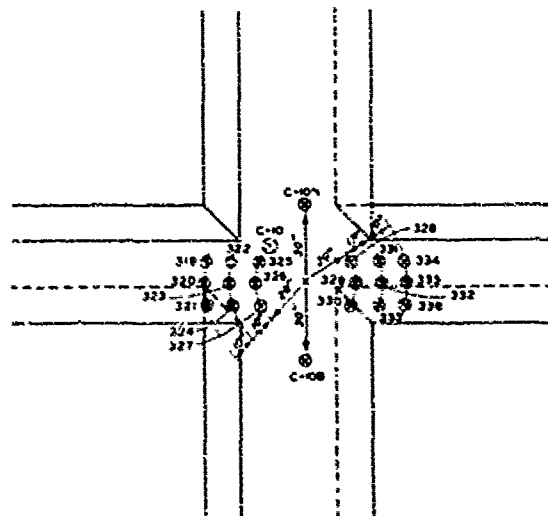
Station location diagram

Station Numbers	Path Length ft	Velocities fps		Station Numbers	Path Length ft	Diagonal Velocities fps
		Straight Through	Diagonals			
C-10	1.17	12,825		C-10 to 326	2.03	15,265
335	1.17	14,570		C-10 to 327	2.03	14,195
C-10 to C-10A	2.76		14,525	C-10 to 328	2.03	10,355
C-10 to C-10B	2.76		14,525	C-10 to 329	2.03	9,855
C-10 to 319	3.53		13,420	C-10 to 330	2.03	11,405
C-10 to 320	3.53		13,170	C-10 to 331	2.76	9,585
C-10 to 321	3.53		14,175	C-10 to 332	2.76	10,495
C-10 to 322	2.76		14,300	C-10 to 333	2.76	8,680
C-10 to 323	2.76		15,080	C-10 to 334	3.53	9,050
C-10 to 324	2.76		14,225	C-10 to 335	3.53	8,715
C-10 to 325	2.03		16,370	C-10 to 336	3.53	10,170

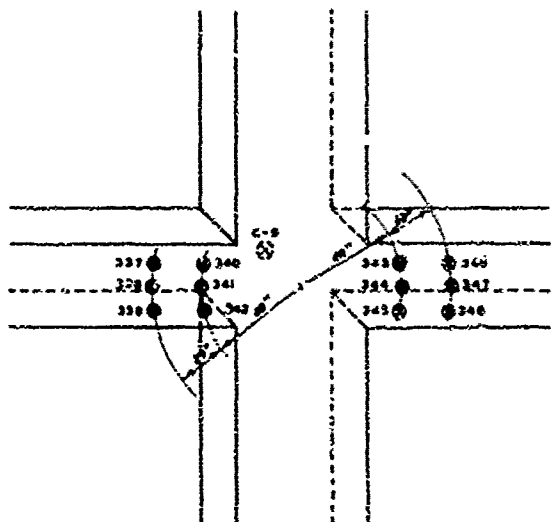
Station location diagram

Station Numbers	Path Length ft	Velocities fps	
		Straight Through	Diagonal
C-8	1.17	15,195	
C-8 to 337	5.13		10,020
C-8 to 338	5.13		13,035
C-8 to 339	5.13		11,305
C-8 to 340	3.53		13,320
C-8 to 341	3.53		12,430
C-8 to 342	3.53		10,895
C-8 to 343	3.53		14,350
C-8 to 344	3.53		14,350
C-8 to 345	3.53		14,350
C-8 to 346	5.13		14,210
C-8 to 347	5.13		13,902
C-8 to 348	5.13		14,100

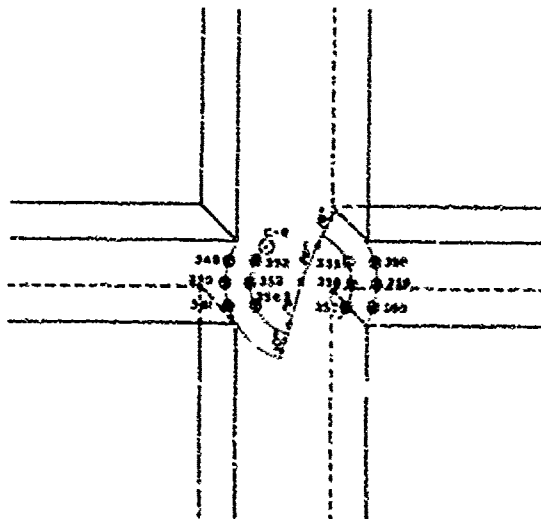
Station location diagram

Station Numbers	Path Length ft	Velocities fpg	
		Straight Through	Diagonals
C-6	1.17	14,810	
C-6 to 349	2.76		12,105
C-6 to 350	2.76		13,940
C-6 to 351	2.76		" )
C-6 to 352	2.03		"
C-6 to 353	2.03		0
C-6 to 354	2.03		1,500
C-6 to 355	2.03		12,455
C-6 to 356	2.03		14,400
C-6 to 357	2.03		13,270
C-6 to 358	2.76		13,205
C-6 to 359	2.76		13,305
C-6 to 360	2.76		12,050

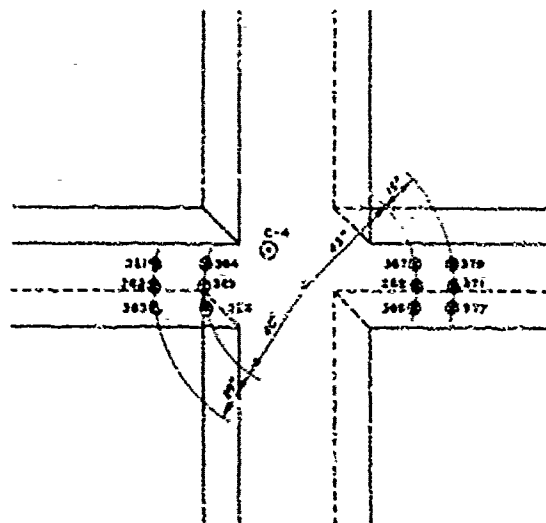
Station location diagram

Station Numbers	Path Length ft	Velocities fps	
		Straight Through	Diagonals
C-4	1.17	14,445	
C-4 to 361	5.13		9,625
C-4 to 362	5.13		10,200
C-4 to 363	5.13		9,450
C-4 to 364	3.53		12,930
C-4 to 365	3.53		10,600
C-4 to 366	3.53		12,255
C-4 to 367	3.93		11,360
C-4 to 368	3.93		12,360
C-4 to 369	3.93		11,800
C-4 to 370	5.13		8,170
C-4 to 371	5.13		11,450
C-4 to 372	5.13		9,410

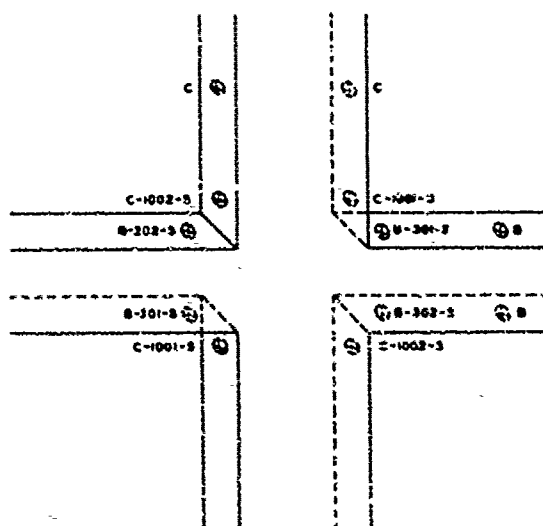
Station location diagram

Results of Soniscope Tests  
 3d Floor Spandrel Beam at Column 10  
 Column-Beam Readings Through Outer 6 in.  
 South Side of Building

<u>Station Numbers</u>	<u>Path Length ft</u>	<u>Velocities fps</u>	
		<u>Straight Through</u>	<u>Diagonals</u>
B-301-S	3.7		13,355
B-302-S	3.7		13,755
C-1001-S	3.8		13,620
C-1002-S	3.75		13,890
C	1.7	15,180	
B	2.6	14,130

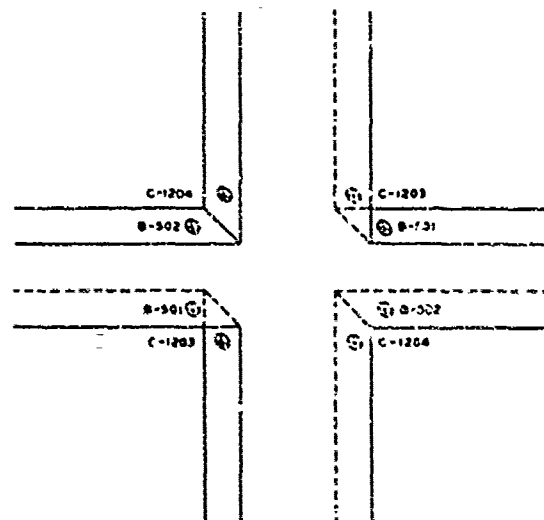
Station location diagram

Results of Soniscope Tests  
 5th Floor Spandrel Beam at Column 12  
 Column-Beam Readings Through Outer 6 in.  
 North Side of Building

<u>Station Numbers</u>	<u>Path Length ft</u>	<u>Diagonal Velocities fps</u>
B-501	5.6	12,785
B-502	5.7	10,775
C-1203	5.4	14,675
C-1204	5.3	14,133

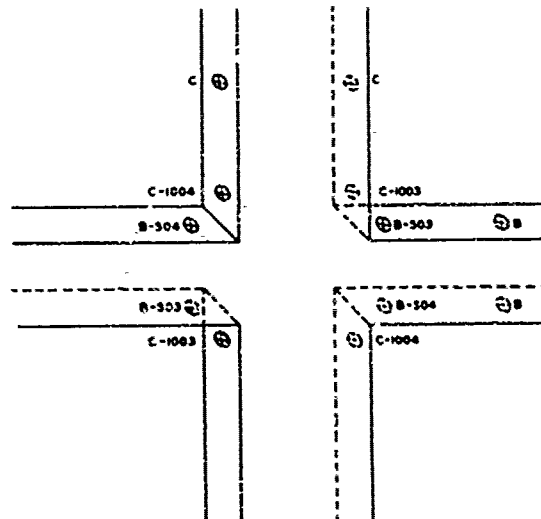
Station location diagram

<u>Station Numbers</u>	<u>Path Length ft</u>	<u>Velocities fps</u>	
		<u>Straight Through</u>	<u>Diagonals</u>
B-503	3.3		14,165
B-504	3.6		14,285
C-1003	3.6		15,126
C-1004	3.9		14,285
C	4.3	15,560	
B	2.6	15,030

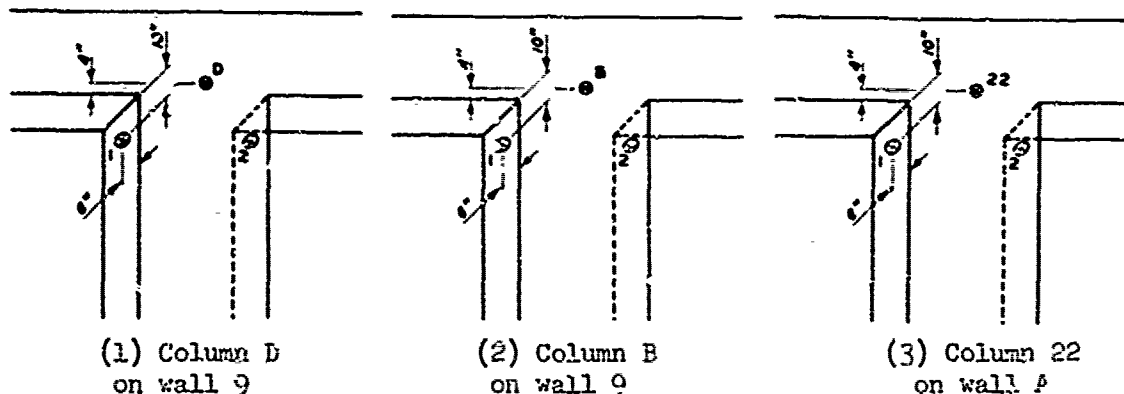
A. Column-beam connections (grouted)

Table 35  
Results of Soniscope Tests  
 Readings on Column-Beam Connections  
 Around Outpatient Clinic  
 (Grouted)

<u>Station Numbers</u>	<u>Path Length ft</u>	<u>Diagonal Velocities fps</u>
D to 1	1.18	14,935
D to 2	1.18	15,130
B to 1	1.18	12,555
B to 2	1.18	12,555
Col 22 to 1	1.18	15,325
Col 22 to 2	1.18	15,325
Column A	2.36	11,455
Column 29	2.36	14,305
